**Flood Control Project Maintenance
Levee Inspections**

Maintenance Issue Types Only, Levee Inspection Report By Mile - Spring 2016

Reclamation District No. 1602 Del Puerto

Waterway	Bank	Unit Miles	Inspection Start/End	Inspector
Unit No. 01 San Joaquin River	Left	6.24	04/07/2016 04/07/2016	Pavel Kazi

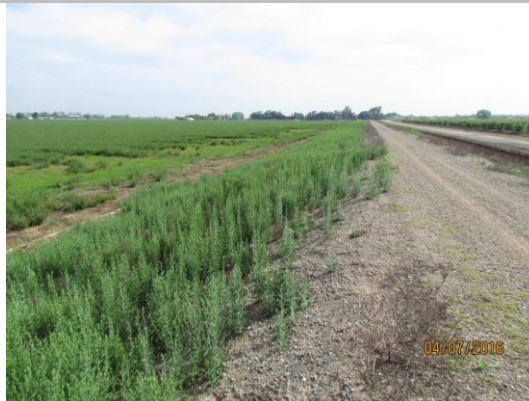
Photo 1 of 1 : SP_2016_RD1602_110_21_20160408_00095.jpg

LM Start	0.13	Rating **	M	Issue No.	21
LM End	0.56	Issue Type +	Ma	Location *	WS
Category	Earthen Levee			GPS Latitude/Longitude	
				Start	End
Item	Vegetation			37.477233 °	37.480269 °
				-121.081740 °	-121.075104 °
DWR ID	DWR_RD1602_01_f_2015_21				
Comment Code					
V1 : Control annual grass and weeds on the levee slopes and easements.					
Inspector Comment

View of the vegetation on the waterside of the levee.

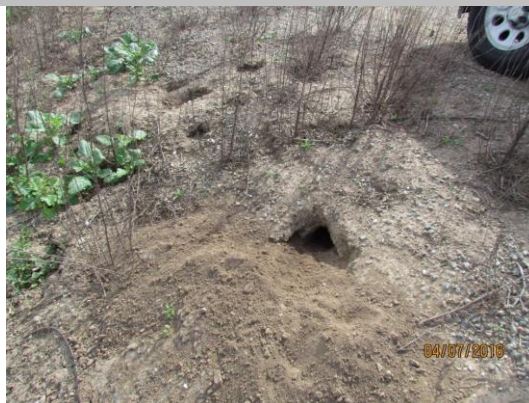
Photo 1 of 2 : SP_2016_RD1602_110_28_20160408_00094.jpg

LM Start	0.20	Rating **	M	Issue No.	28
LM End	0.20	Issue Type +	Ma	Location *	WS
Category	Earthen Levee			GPS Latitude/Longitude	
				Start	End
Item	Animal Control			37.477706 °	37.477706 °
				-121.080674 °	-121.080674 °
DWR ID	DWR_RD1602_01_f_2015_28				
Comment Code					
A3 : No rodents visible, but rodent burrows visible; need to backfill and compact or grout burrows.					
Inspector Comment

Updated picture of the rodent hole on the waterside of the levee during spring 2016 inspection.

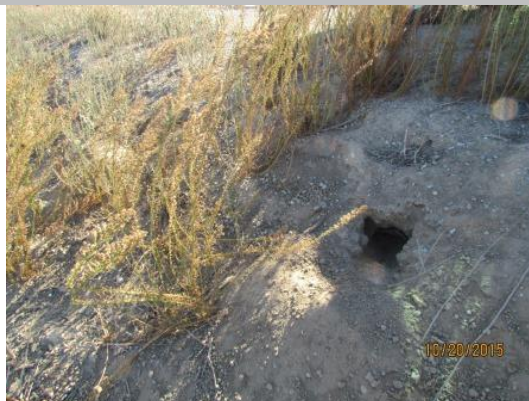
Photo 2 of 2 : SP_2016_RD1602_110_28_20160219_00009.jpg

LM Start	0.20	Rating **	M	Issue No.	28 (cont)	
LM End	0.20	Issue Type +	Ma	Location *	WS	
Category	Earthen Levee			GPS Latitude/Longitude		
				Start		End
Item	Animal Control			37.477706 °		37.477706 °
				-121.080674 °		-121.080674 °
DWR ID	DWR_RD1602_01_f_2015_28					
Comment Code						
A3 : No rodents visible, but rodent burrows visible; need to backfill and compact or grout burrows.						
Inspector Comment

A rodent hole was found on the waterside of the levee.

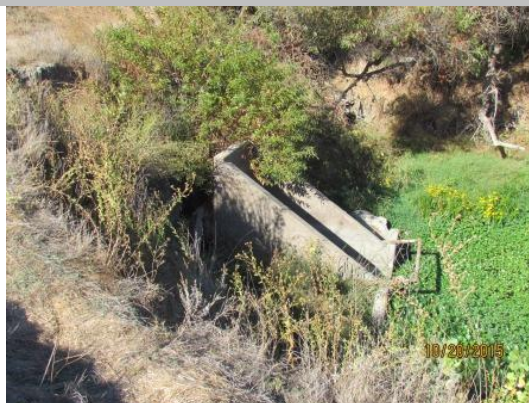
Photo 1 of 3 : SP_2016_RD1602_110_55_20160219_00027.jpg

LM Start	1.02	Rating **	U	Issue No.	55
LM End	1.02	Issue Type +	Ma	Location *	WS
Category	Interior Drainage & Piping Systems			GPS Latitude/Longitude	
				Start	End
Item	Concrete Tilting / Settlement			37.478772 °	37.478772 °
				-121.068454 °	-121.068454 °
DWR ID	DWR_RD1602_01_s_2012_55				
Comment Code					
Inspector Comment					
The outlet headwall is tilting away from the pipe rendering the existing flap gate ineffective. The LMA is planning to repair gap between pipe and headwall and stabilize headwall to prevent further damage.

View of the broken headwall on the waterside of the levee during fall 2015 inspection.

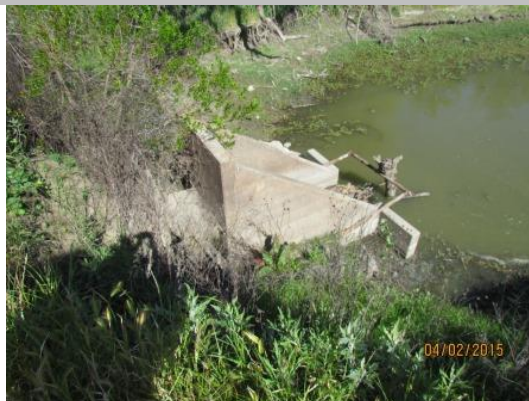
Photo 2 of 3 : SP_2016_RD1602_110_55_20160219_00028.jpg

LM Start	1.02	Rating **	U	Issue No.	55 (cont)	
LM End	1.02	Issue Type +	Ma	Location *	WS	
Category	Interior Drainage & Piping Systems			GPS Latitude/Longitude		
				Start		End
Item	Concrete Tilting / Settlement			37.478772 °	37.478772 °	
				-121.068454 °	-121.068454 °	
DWR ID	DWR_RD1602_01_s _ 2012_55					
Comment Code						
Inspector Comment						
The outlet headwall is tilting away from the pipe rendering the existing flap gate ineffective. The LMA is planning to repair gap between pipe and headwall and stabilize headwall to prevent further damage.

View of the broken headwall on the waterside of the levee during spring 2015 inspection.

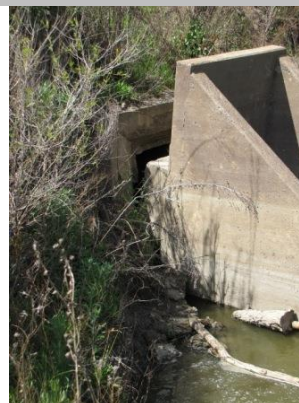
Photo 3 of 3 : SP_2016_RD1602_110_55_20160219_00029.jpg

LM Start	1.02	Rating **	U	Issue No.	55 (cont)
LM End	1.02	Issue Type +	Ma	Location *	WS

Separation of outfall structure from the outlet pipe.

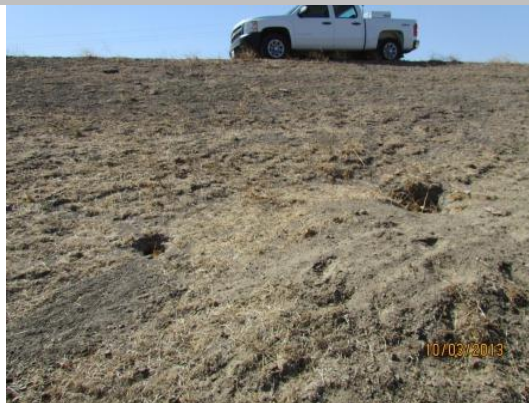
Photo 1 of 2 : SP_2016_RD1602_110_11_20160219_00002.jpg

LM Start	1.11	Rating **	M	Issue No.	11
LM End	1.11	Issue Type +	Ma	Location *	WS
Category	Earthen Levee			GPS Latitude/Longitude	
				Start	End
Item	Animal Control			37.478371 °	37.478371 °
				-121.066793 °	-121.066793 °
DWR ID	DWR_RD1602_01_s_2013_11				
Comment Code					
A3 : No rodents visible, but rodent burrows visible; need to backfill and compact or grout burrows.					
Inspector Comment

Rodent holes were found on the waterside slope of the levee looking downstream.

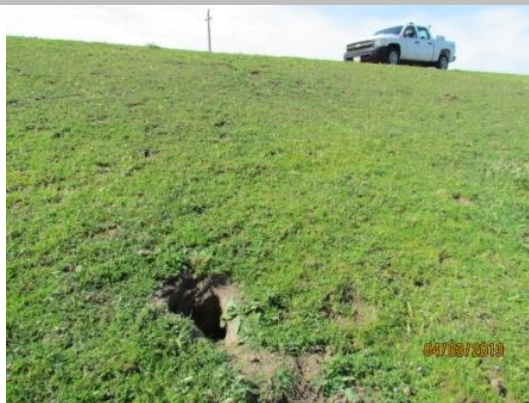
Photo 2 of 2 : SP_2016_RD1602_110_11_20160219_00003.jpg

LM Start	1.11	Rating **	M	Issue No.	11 (cont)	
LM End	1.11	Issue Type +	Ma	Location *	WS	
Category	Earthen Levee			GPS Latitude/Longitude		
				Start		End
Item	Animal Control			37.478371 °	37.478371 °	
				-121.066793 °	-121.066793 °	
DWR ID	DWR_RD1602_01_s_2013_11					
Comment Code						
A3 : No rodents visible, but rodent burrows visible; need to backfill and compact or grout burrows.						
Inspector Comment

A rodent hole was found on the waterside toe of the levee looking downstream.

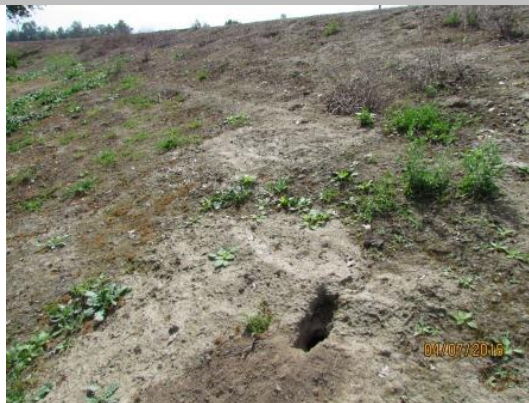
Photo 1 of 2 : SP_2016_RD1602_110_65_20160411_00096.jpg

LM Start	1.14	Rating **	M	Issue No.	65
LM End	1.14	Issue Type +	Ma	Location *	WS
Category	Earthen Levee			GPS Latitude/Longitude	
				Start	End
Item	Animal Control			37.478285 °	37.478285 °
				-121.066299 °	-121.066299 °
DWR ID	DWR_RD1602_01_f_2012_65				
Comment Code					
A3 : No rodents visible, but rodent burrows visible; need to backfill and compact or grout burrows.					
Inspector Comment

Updated picture of the rodent hole on waterside of the levee during spring 2016 inspection.

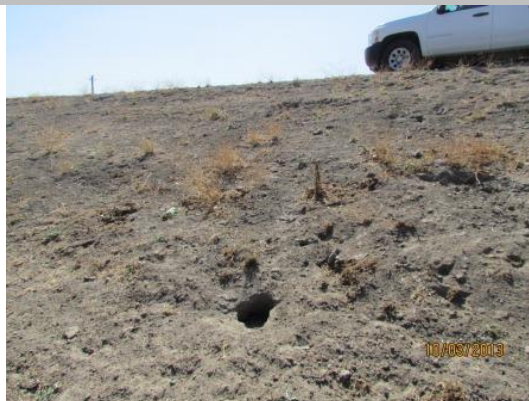
Photo 2 of 2 : SP_2016_RD1602_110_65_20160219_00037.jpg

LM Start	1.14	Rating **	M	Issue No.	65 (cont)	
LM End	1.14	Issue Type +	Ma	Location *	WS	
Category	Earthen Levee			GPS Latitude/Longitude		
				Start		End
Item	Animal Control			37.478285 °		37.478285 °
				-121.066299 °		-121.066299 °
DWR ID	DWR_RD1602_01_f_2012_65					
Comment Code						
A3 : No rodents visible, but rodent burrows visible; need to backfill and compact or grout burrows.						
Inspector Comment

View of rodent hole on the waterside slope of the levee looking upstream during fall 2013 inspection.

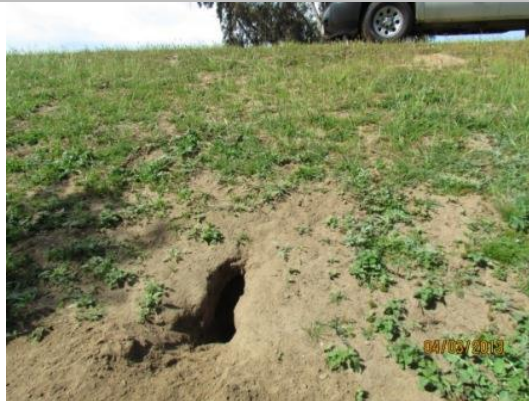
Photo 1 of 1 : SP_2016_RD1602_110_18_20160219_00004.jpg

LM Start	1.69	Rating **	U	Issue No.	18
LM End	1.69	Issue Type +	Ma	Location *	WS
Category	Earthen Levee			GPS Latitude/Longitude	
				Start	End
Item	Animal Control			37.476576 °	37.476576 °
				-121.058174 °	-121.058174 °
DWR ID	DWR_RD1602_01_s _ 2013_18				
Comment Code					
A3 : No rodents visible, but rodent burrows visible; need to backfill and compact or grout burrows.					
Inspector Comment

A rodent hole was found on the waterside toe of the levee looking downstream.

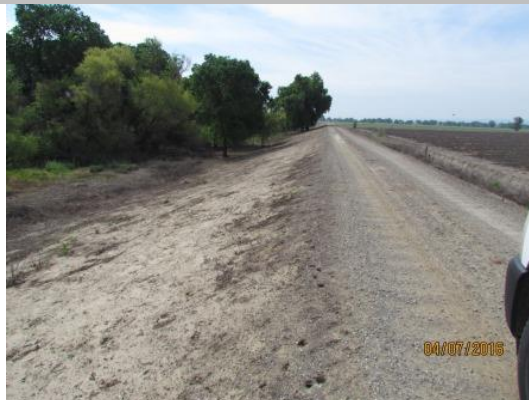
Photo 1 of 1 : SP_2016_RD1602_110_16_20160411_00097.jpg

LM Start	1.84	Rating **	A	Issue No.	16
LM End	1.84	Issue Type +	Ma	Location *	WS
Category	Earthen Levee			GPS Latitude/Longitude	
				Start	End
Item	Vegetation			37.474555 °	37.474555 °
				-121.057932 °	-121.057932 °
DWR ID	DWR_RD1602_01_s _ 2016_16				
Comment Code					
V1 : Control annual grass and weeds on the levee slopes and easements.					
Inspector Comment					
LMA removed the vegetation on the waterside slope of the levee.

View of an acceptable vegetation on the waterside slope of the levee.

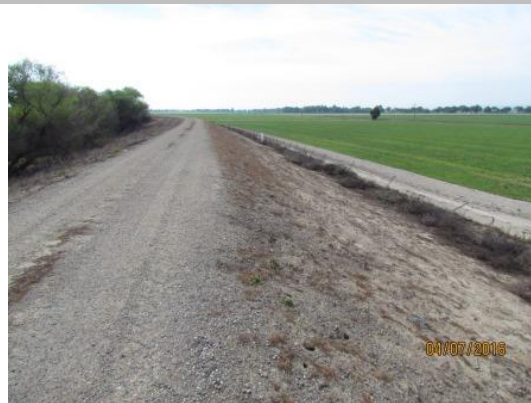
Photo 1 of 1 : SP_2016_RD1602_110_17_20160411_00098.jpg

LM Start	2.04	Rating **	A	Issue No.	17
LM End	2.04	Issue Type +	Ma	Location *	LS
Category	Earthen Levee			GPS Latitude/Longitude	
				Start	End
Item	Vegetation			37.471585 °	37.471585 °
				-121.057586 °	-121.057586 °
DWR ID	DWR_RD1602_01_s_2016_17				
Comment Code					
V1 : Control annual grass and weeds on the levee slopes and easements.					
Inspector Comment

View of an acceptable vegetation on the landside slope of the levee.

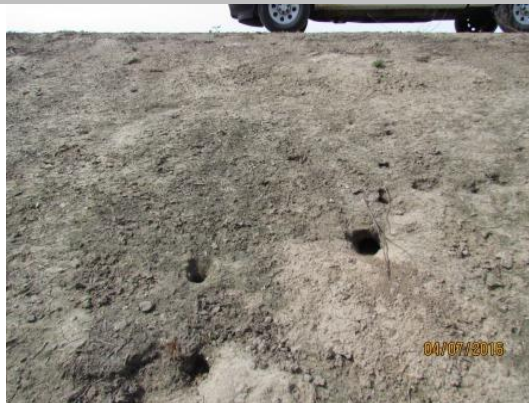
Photo 1 of 1 : SP_2016_RD1602_110_19_20160411_00099.jpg

View of rodent holes on the waterside of the levee.

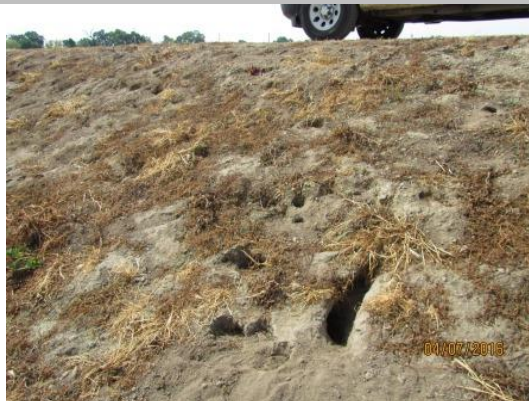
Photo 1 of 1 : SP_2016_RD1602_110_24_20160411_00100.jpg

View of rodent holes on the waterside of the levee looking upstream.

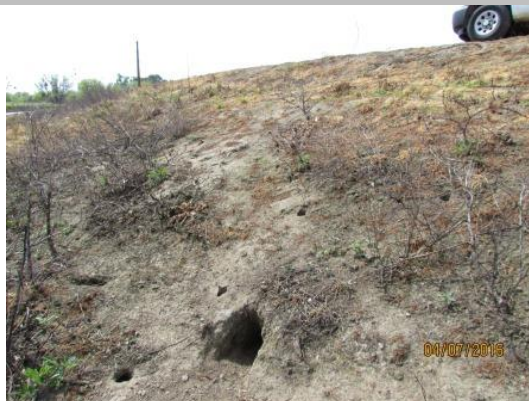
Photo 1 of 1 : SP_2016_RD1602_110_25_20160411_00101.jpg

View of rodent holes on the waterside toe of the levee looking upstream.

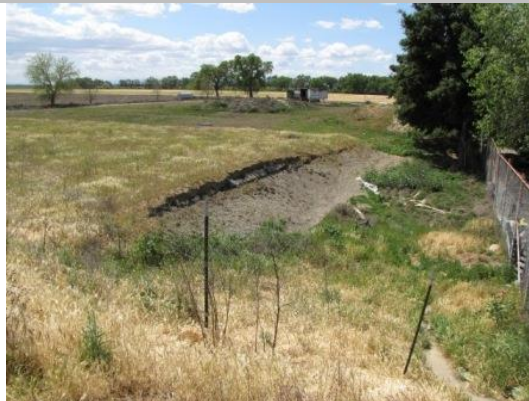
Photo 1 of 1 : SP_2016_RD1602_110_62_20160219_00034.jpg

LM Start	3.93	Rating **	M	Issue No.	62
LM End	3.93	Issue Type +	Ma	Location *	LS
Category	Earthen Levee			GPS Latitude/Longitude	
				Start	End
Item	Slope Stability			37.453216 °	37.453216 °
				-121.042127 °	-121.042127 °
DWR ID	DWR_RD1602_01_s_2012_62				
Comment Code					
S3 : Repair the levee slope damaged by vehicle traffic and prevent access where possible.					
Inspector Comment					
Significant damage to USACE constructed seepage berm due to human activity.

Repair damage to USACE constructed seepage berm by pedestrian and cycle traffic.

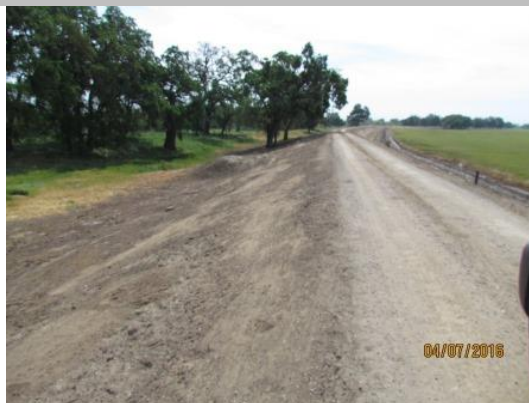
Photo 1 of 1 : SP_2016_RD1602_110_27_20160411_00102.jpg

View of an acceptable vegetation on the waterside of the levee looking upstream.

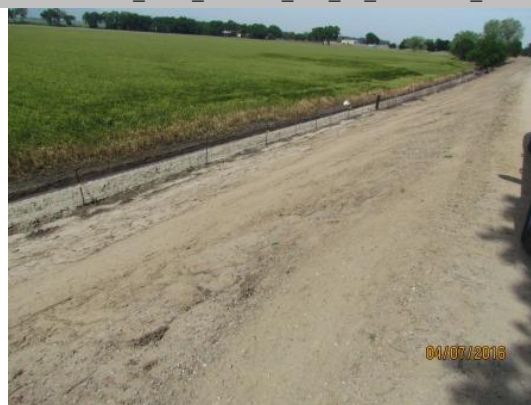
Photo 1 of 1 : SP_2016_RD1602_110_30_20160411_00103.jpg

LMA has repaired multiple rodent holes on the landside slope of the levee looking downstream.

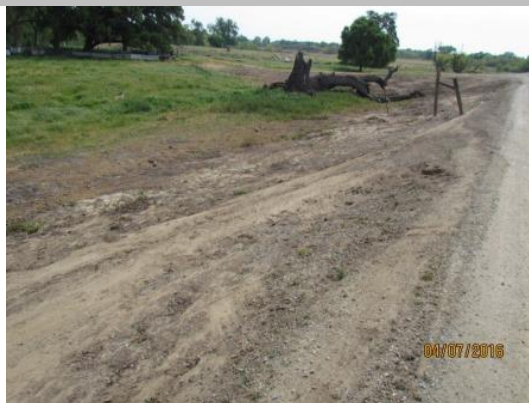
Photo 1 of 1 : SP_2016_RD1602_110_32_20160411_00104.jpg

LMA has repaired the rodent holes on the waterside slope of the levee during spring 2016 inspection.

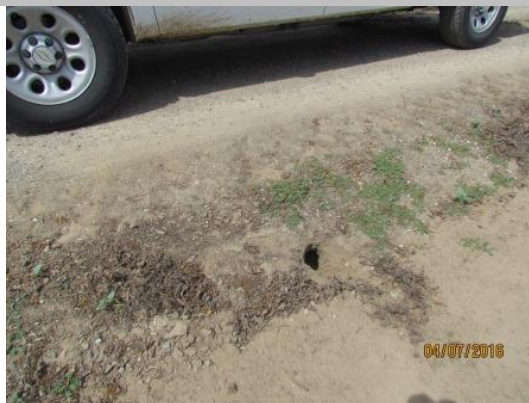
Photo 1 of 1 : SP_2016_RD1602_110_35_20160411_00105.jpg

View of an animal hole on the waterside shoulder of the levee looking downstream.

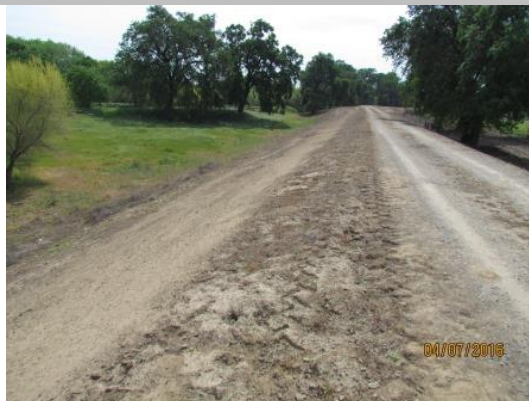
Photo 1 of 1 : SP_2016_RD1602_110_40_20160411_00106.jpg

View of an acceptable vegetation on the waterside slope of the levee looking upstream.

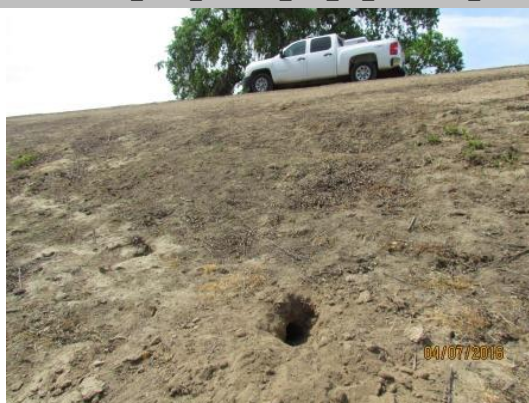
Photo 1 of 1 : SP_2016_RD1602_110_74_20160411_00107.jpg

LM Start	4.77	Rating **	M	Issue No.	74
LM End	4.77	Issue Type +	Ma	Location *	WS
Category	Earthen Levee			GPS Latitude/Longitude	
				Start	End
Item	Animal Control			37.442465 °	37.442465 °
				-121.036947 °	-121.036947 °
DWR ID	DWR_RD1602_01_s_2015_74				
Comment Code					
A3 : No rodents visible, but rodent burrows visible; need to backfill and compact or grout burrows.					
Inspector Comment

View of a rodent hole on the waterside toe of the levee.

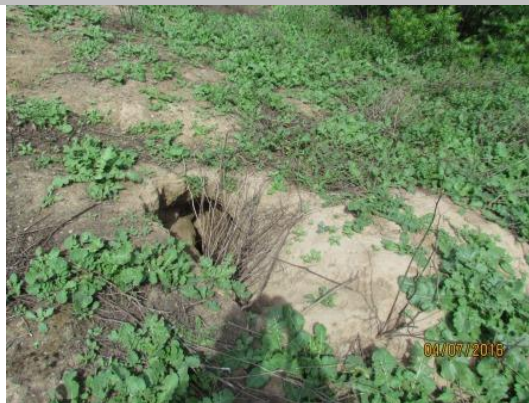
Photo 1 of 1 : SP_2016_RD1602_110_48_20160411_00108.jpg

View of rodent holes on the waterside of the levee looking downstream.

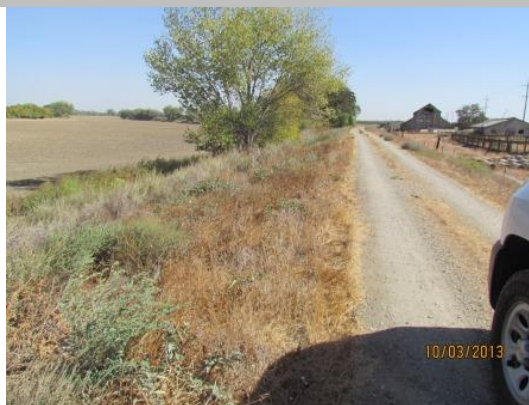
Photo 1 of 2 : SP_2016_RD1602_110_75_20160219_00045.jpg

LM Start	5.29	Rating **	M	Issue No.	75
LM End	5.49	Issue Type +	Ma	Location *	WS
Category	Earthen Levee			GPS Latitude/Longitude	
				Start	End
Item	Vegetation			37.435555 °	37.433277 °
				-121.035362 °	-121.033318 °
DWR ID	DWR_RD1602_01_s _ 2012_75				
Comment Code					
V2 : Remove the wild growth other than native grasses from the levee slopes.					
Inspector Comment

Vegetation was found on the waterside slope of the levee looking upstream during fall 2013 inspection.

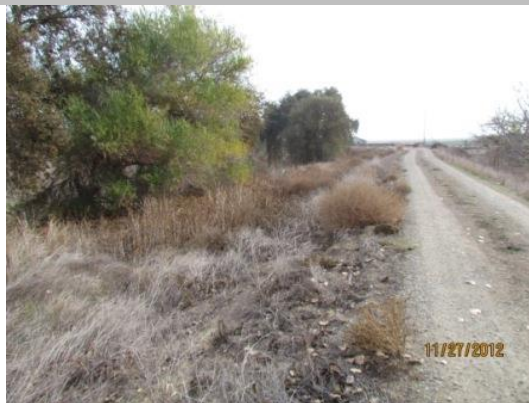
Photo 2 of 2 : SP_2016_RD1602_110_75_20160219_00046.jpg

LM Start	5.29	Rating **	M	Issue No.	75 (cont)
LM End	5.49	Issue Type +	Ma	Location *	WS

Overgrown vegetation was found on the waterside slope of the levee looking upstream.

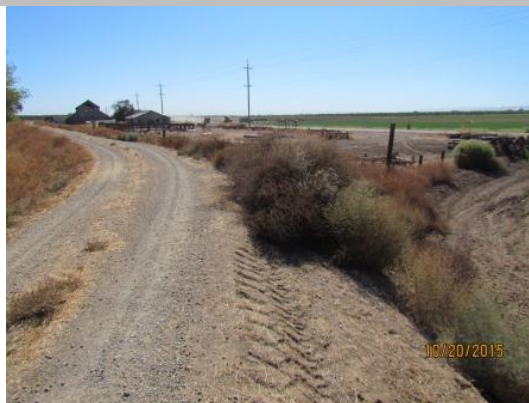
Photo 1 of 1 : SP_2016_RD1602_110_61_20160219_00033.jpg

Vegetation was obstructing the view of the landside of the levee.
